**RECOMMENDATIONS FOR REPAIR OF  
SPRAY POLYURETHANE FOAM (SPF) ROOF  
SYSTEMS DUE TO  
HAIL AND WIND DRIVEN DAMAGE**

**RECOMMENDED  
DESIGN CONSIDERATIONS  
AND GUIDE SPECIFICATIONS**

**Spray Polyurethane Foam Alliance  
Copyright January 2003**

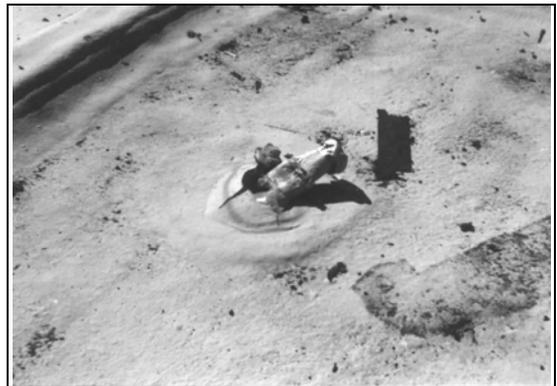
### 1) Mechanical damage due to wind driven missiles

During high wind events a wide variety of objects can potentially impact a roof and produce damage to the protective coating and SPF. This damage may be isolated to small areas of the roof or cover large areas. Substrate and structural damage may or may not have occurred and should be thoroughly investigated. The type of repairs required will depend on the size and severity of the damage and should be consistent with SPFA's Guideline AY-122, "The Renewal of Spray Polyurethane Foam and Coating Roof Systems."

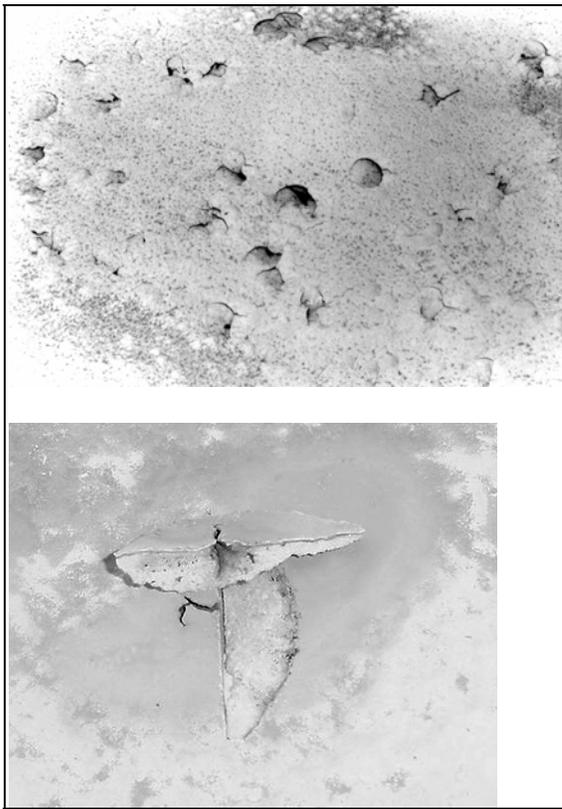
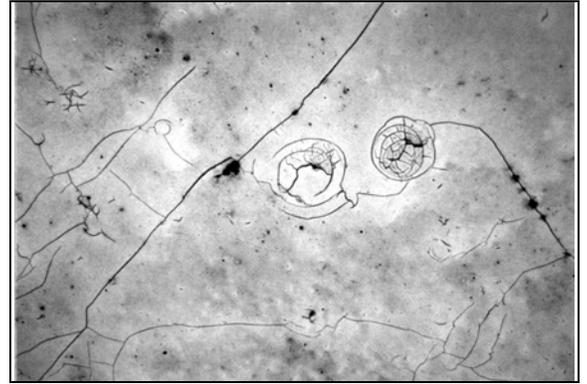
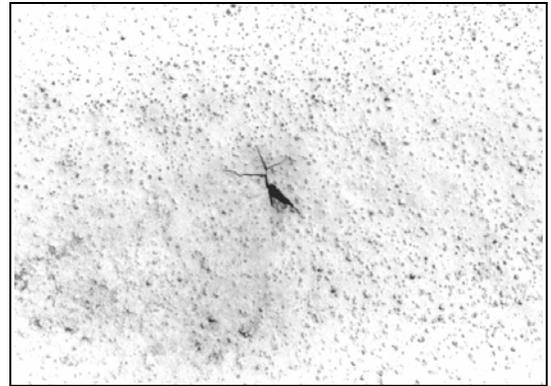
### 2) Hail

Hail can damage both the surface coating and the underlying foam in an SPF roof system.

Coating damage can appear as gouges, cracks, and punctures. Hail induced coating cracks often form patterns shaped like “crow’s feet” or semi-circles.

Depending on hail stone size, shape, and hardness, the underlying foam may be dented, cracked, or gouged. Depressions in SPF dented by hail stones may be 1/8-inch to 3/4-inch deep. Hail damage can be isolated to small areas or cover the entire roof surface.

The repair technique is determined from the severity (size and depth of damage) and extent (number of hail hits per unit area) of the hail damage. For example, fifteen 3-inch diameter hail dents on a 1000 square foot roof may be easier to repair than hundreds of 3/4-inch diameter dents.
